FLOATING AIR BASES AND FLYING BOATS: AN HISTORICAL AND
ARCHAEOLOGICAL STUDY OF THE TWO SEADROMES ESTABLISHED AT SAIPAN

May 2020

A Thesis

East Carolina University

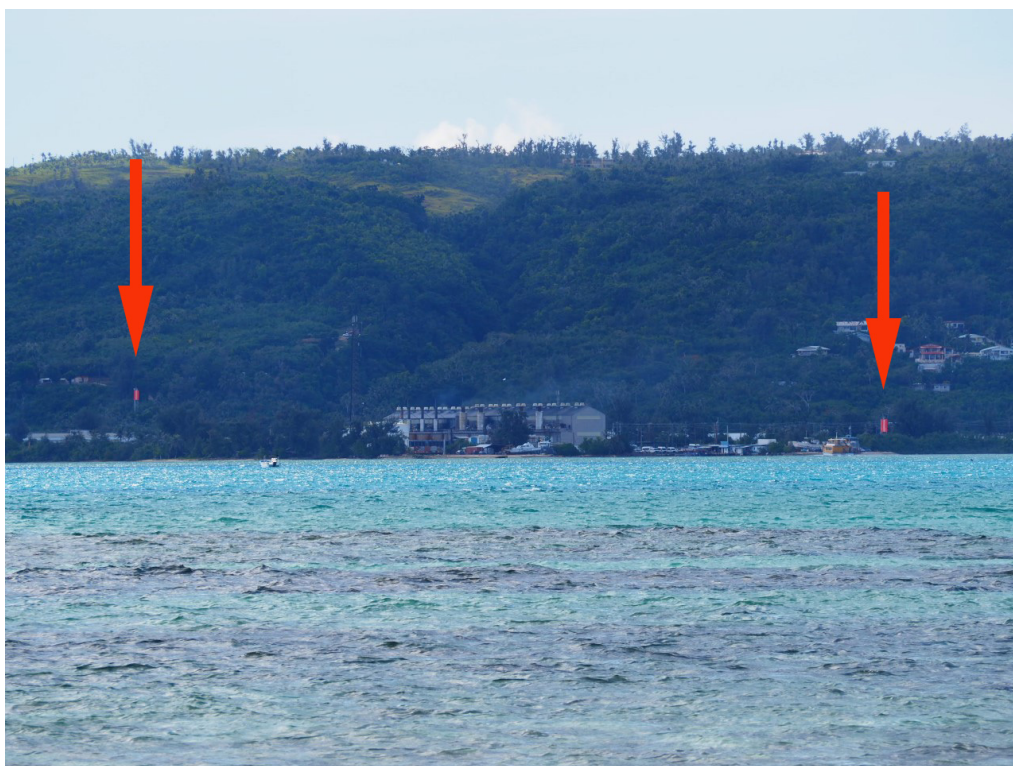
FIGURE 4.15. View of front (right) and rear (left) ranges on Saipan from Mañagaha Island (Photo taken looking approximately east by author 10 July 2019).

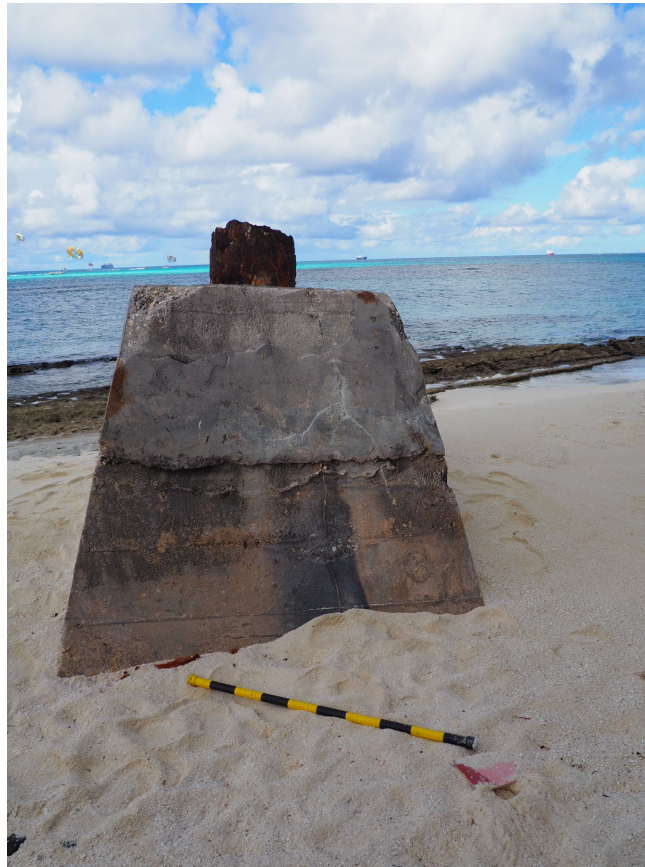
FIGURE 4.17. Front range base on Mañagaha Island. 1-meter scale oriented on approximate north-south axis (north to the right) (Photo taken by author 10 July 2019).

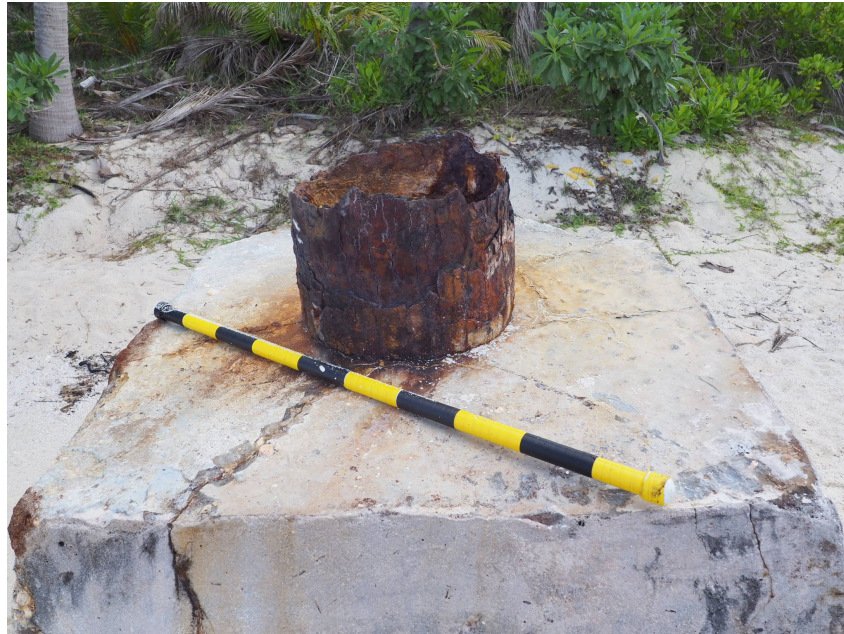
FIGURE 4.18. Ferrous pipe in the center of the range base. 1-meter scale oriented on approximate north-south axis (north to the left) (Photo taken by author 10 July 2019).

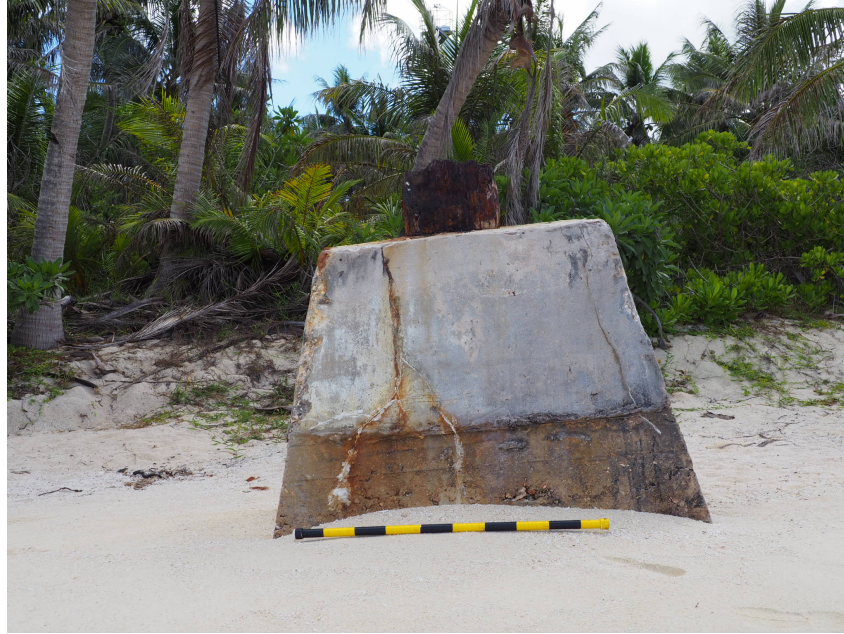
FIGURE 4.19. Front range on Mañagaha Island. Note the evidence of concrete repairs. 1-meter scale (Photo taken looking to the northeast by author 10 July 2019).

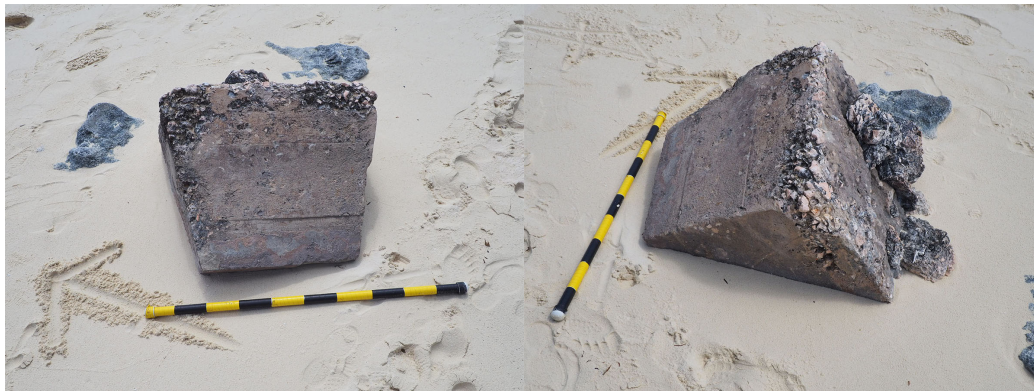
FIGURE 4.20. Northern most artifact of the grouping. Arrow drawn in the sand to indicate north. 1-meter scale (Photos taken by author on 10 July 2019).

northwest-southeast axis over the span of approximately 11 m. Although no ferrous material was observed, it can be deduced from the general shape of the concrete and the location and size of the holes within it that the purpose of these concrete and rock objects was to support a pole or post such as a pylon.

The northern most artifact of the grouping appears to be the most intact. Largely buried in the sand, it is pyramidal in shape with the only measurable side being 72 cm wide at the base and 53 cm wide at the top (FIGURE 4.20). The central artifact is in poor condition. It appears to have been constructed of concrete and rocks or coral. The original shape is indiscernible. A rough hole approximately 20 x 23 x 43 cm deep (FIGURE 4.21). The southernmost artifact of the grouping is approximately rectangular in shape and in fair condition. The top measures 70 x 54 x 68 x 55 cm and protrudes from the sand approximately 28 cm. A square hole 16cm wide runs through the center with one exit being offset to one side and the opposite exit being in the approximate center (FIGURE 4.22).

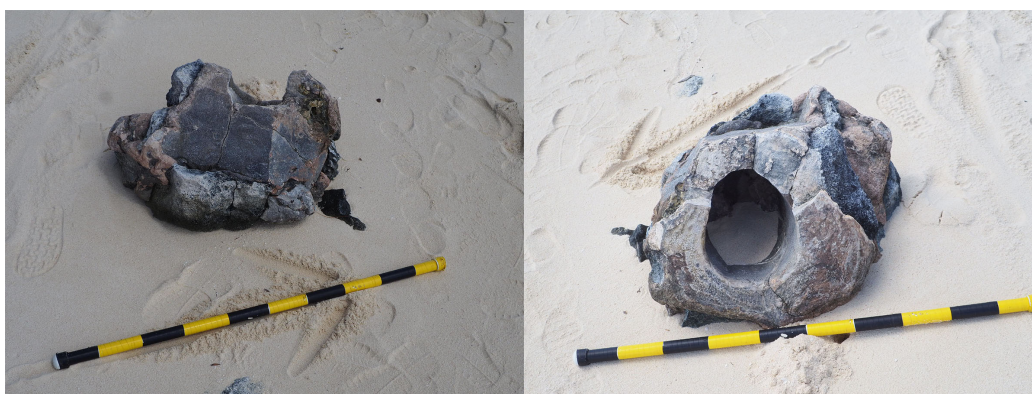
FIGURE 4.22. Southern-most artifact of the grouping. Note the opening in the center of the right photograph. Arrow drawn in the sand indicates north. 1-meter scale (Photos taken by the author on 10 July 2019).

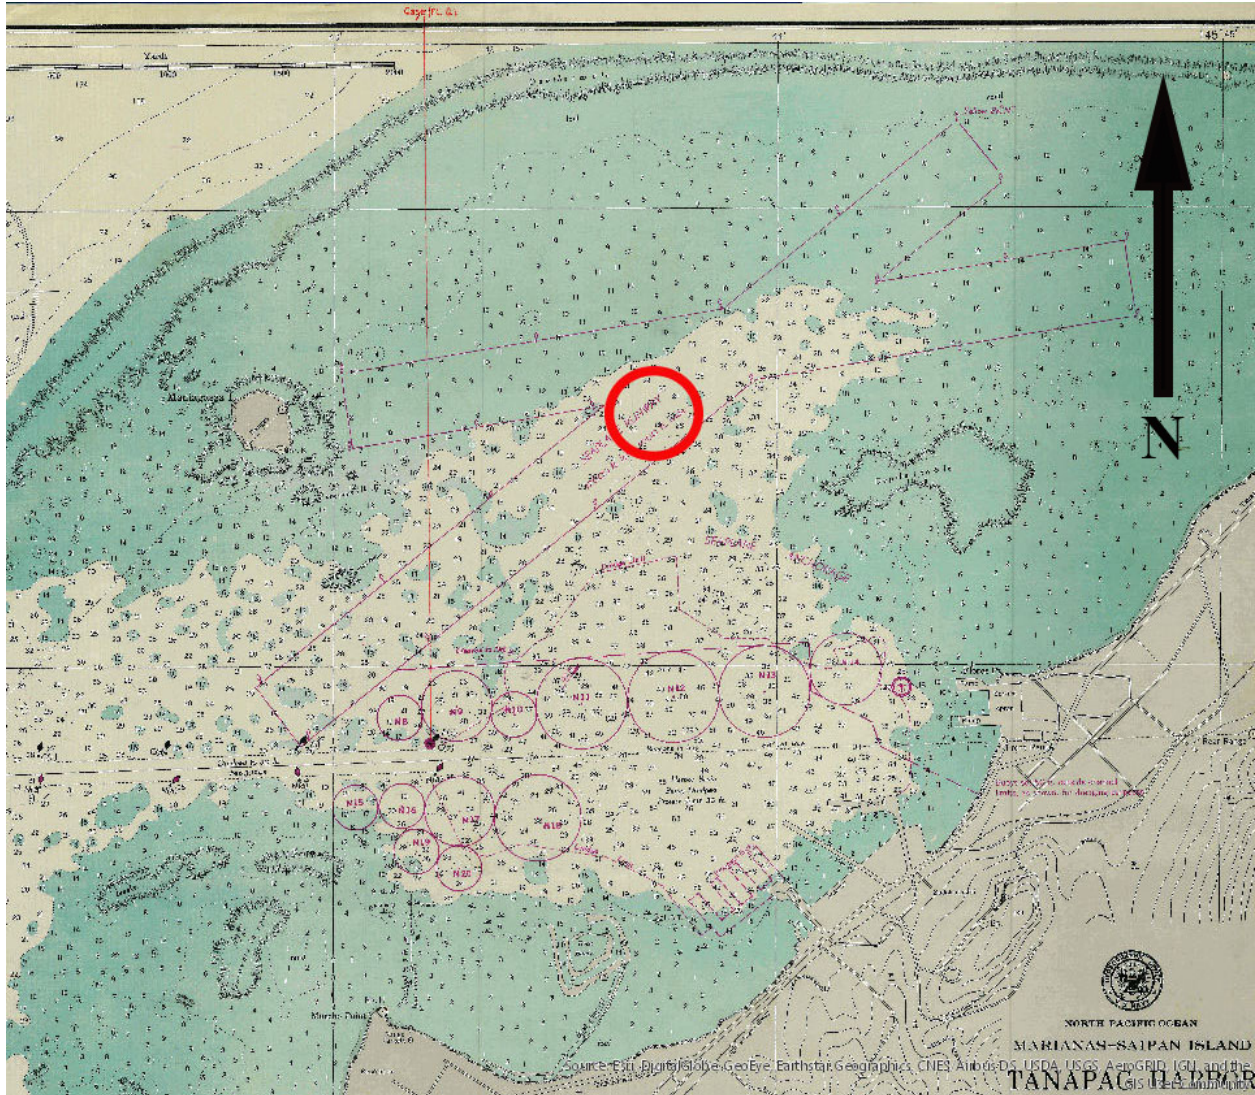
FIGURE 4.23. Central runway grouping of JATO tanks (Figure created in ArcGIS. H.O. Chart 2015A courtesy of NARA Record Group 37).

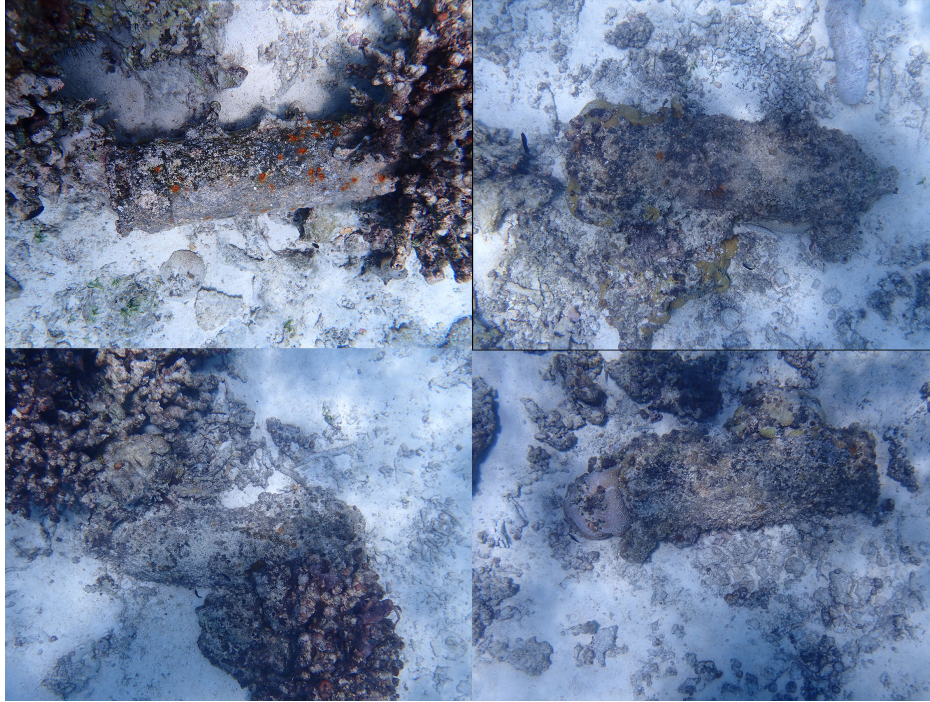
FIGURE 4.25. Four of the five JATO tanks observed during snorkel surveys undertaken on 26 July 2019 (Photo taken by author).

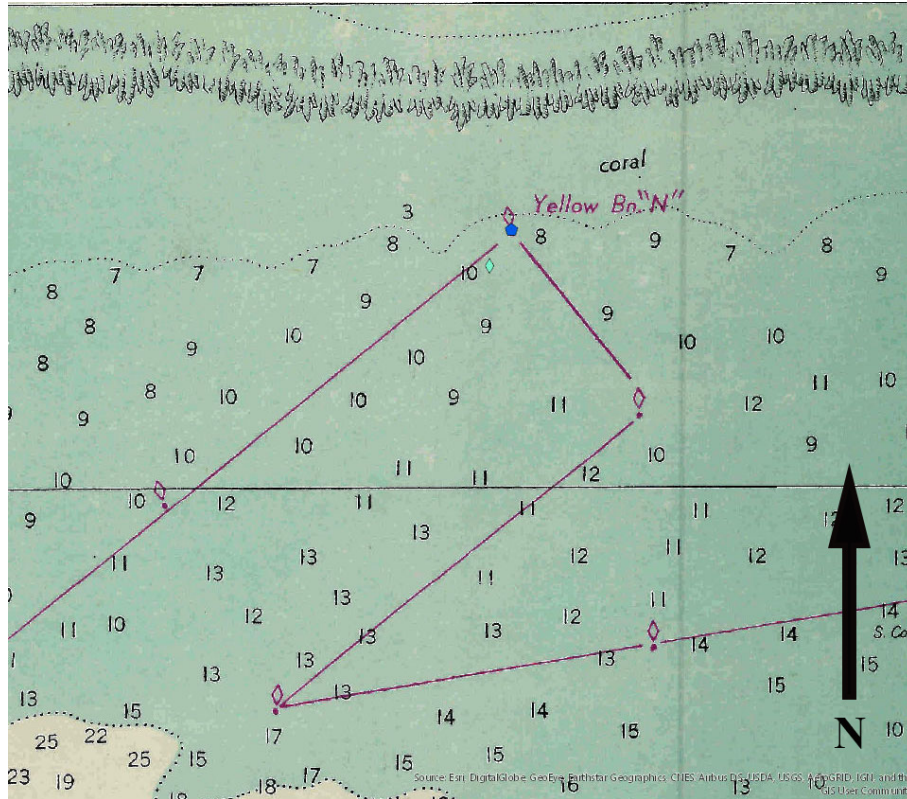
FIGURE 4.26. ArcGIS overlay of GPS points of the possible pylon (blue pentagon) and Navy stockless anchor (teal diamond) overlaid on H.O. Chart No. 2015 (Image enhanced to emphasize area of focus. Chart courtesy of NARA, Record Group 37).

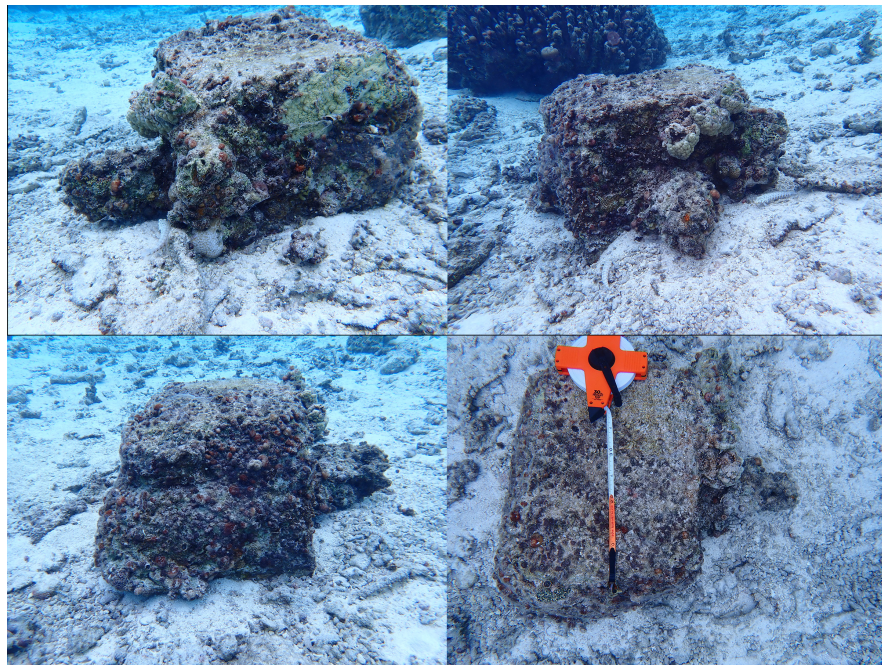
FIGURE 4.27. Possible north runway 5/23 pylon remains (Photos taken by author 26 July 2019).

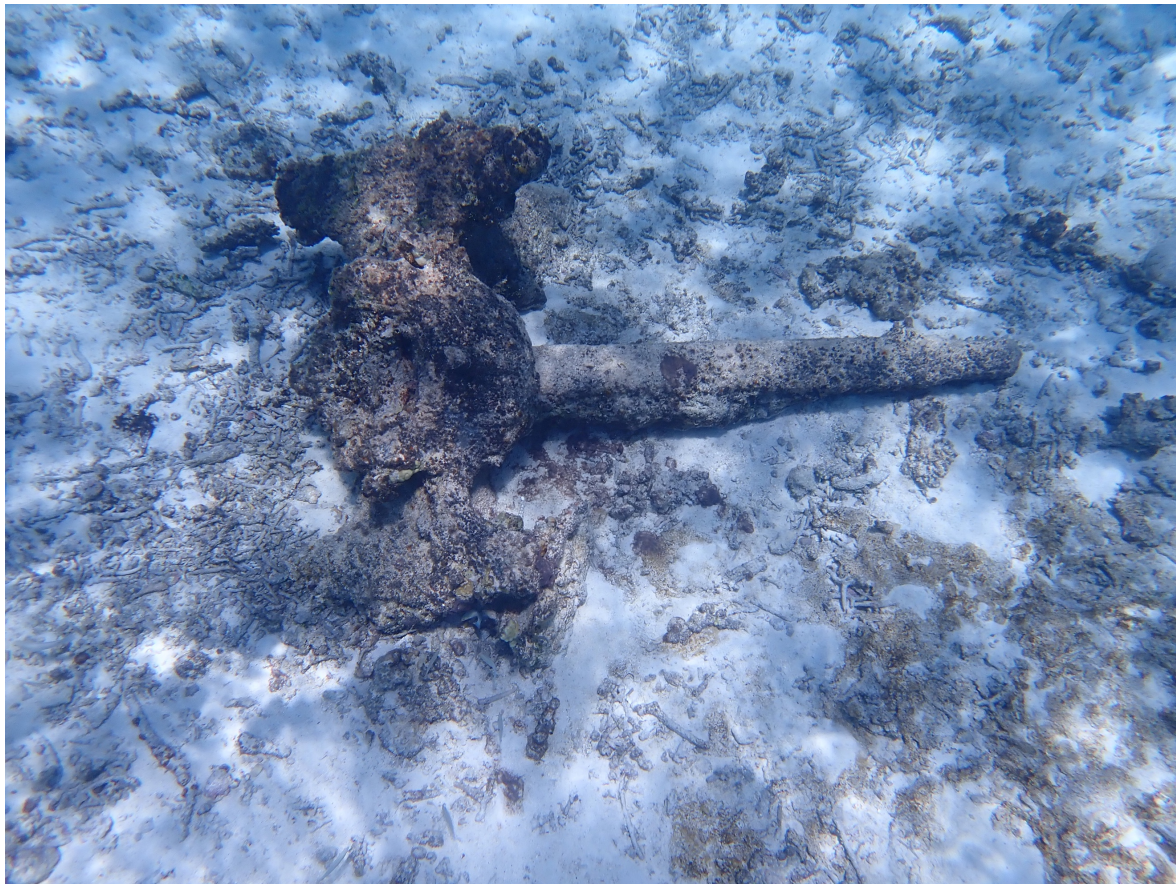
FIGURE 4.28. Navy stockless anchor found in northern runway survey (Photo taken by author on 26 July 2019).

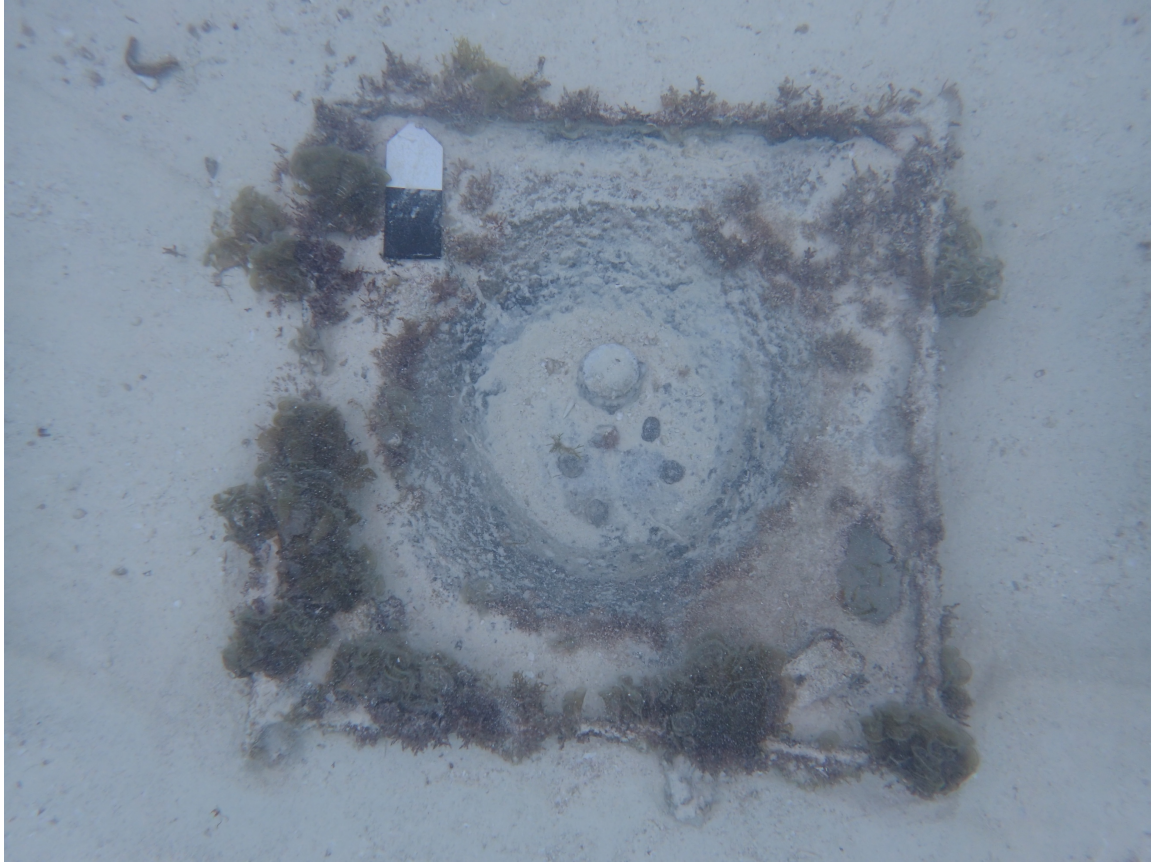
FIGURE 4.29. Possible seadrome buoy mooring (Image courtesy of ECU Program in Maritime Studies 2018).

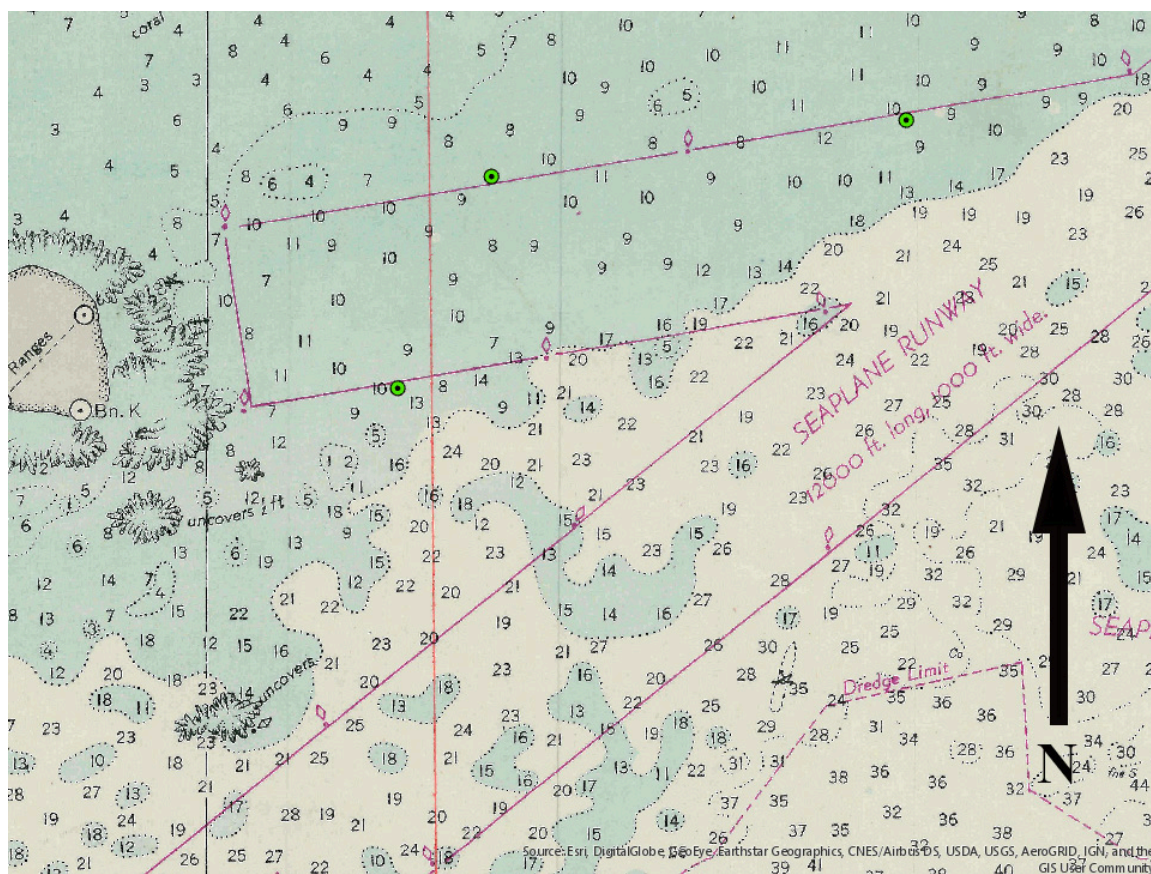
FIGURE 4.30. ArcGIS overlay of GPS locations of possible seadrome buoy moorings. Image created in ArcGIS on H.O. Chart 2015 (Chart courtesy of NARA, Record Group 37).

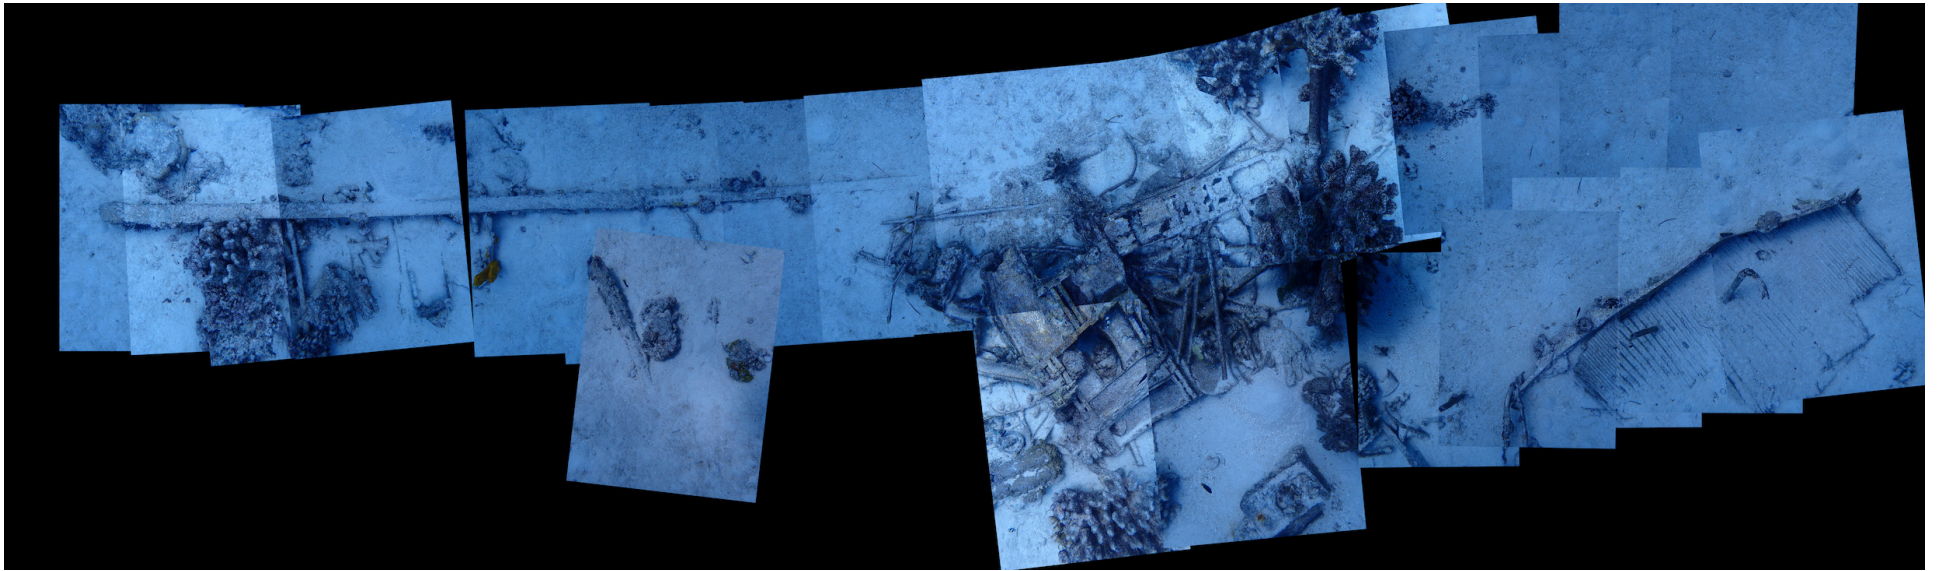
FIGURE 4.34. Photomosaic of the unidentified section of beam cluster and the interior fuselage section (Photographs taken by author on 26 July 2019 and edited in Adobe Photoshop).

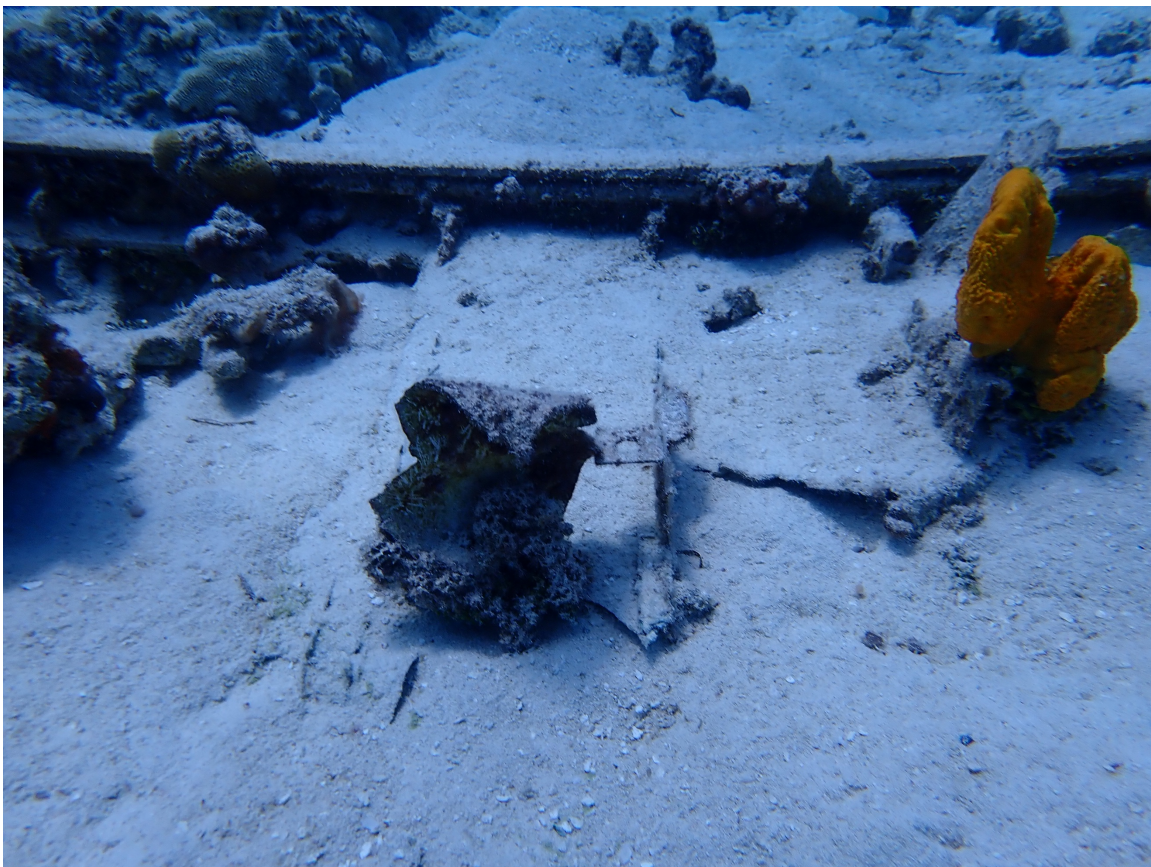
FIGURE 4.35. Image of I-beam illustrating location of formerly attached I-beams. Notice the aluminum skin (Photo taken looking approximately south by author 26 July 2019).

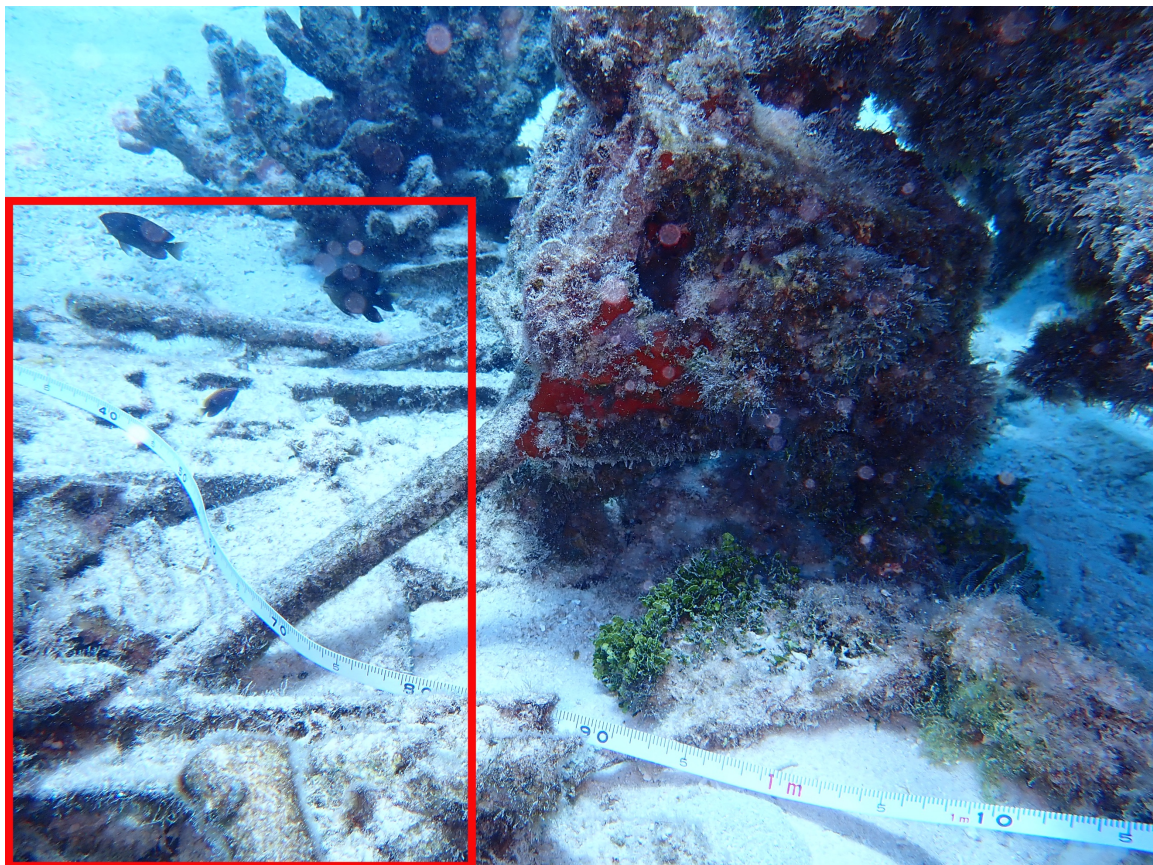
FIGURE 4.36. Possible hatch and anchor davit (emphasized) with nearby winch (right) (Photo taken looking approximately south by author on 26 July 2019).

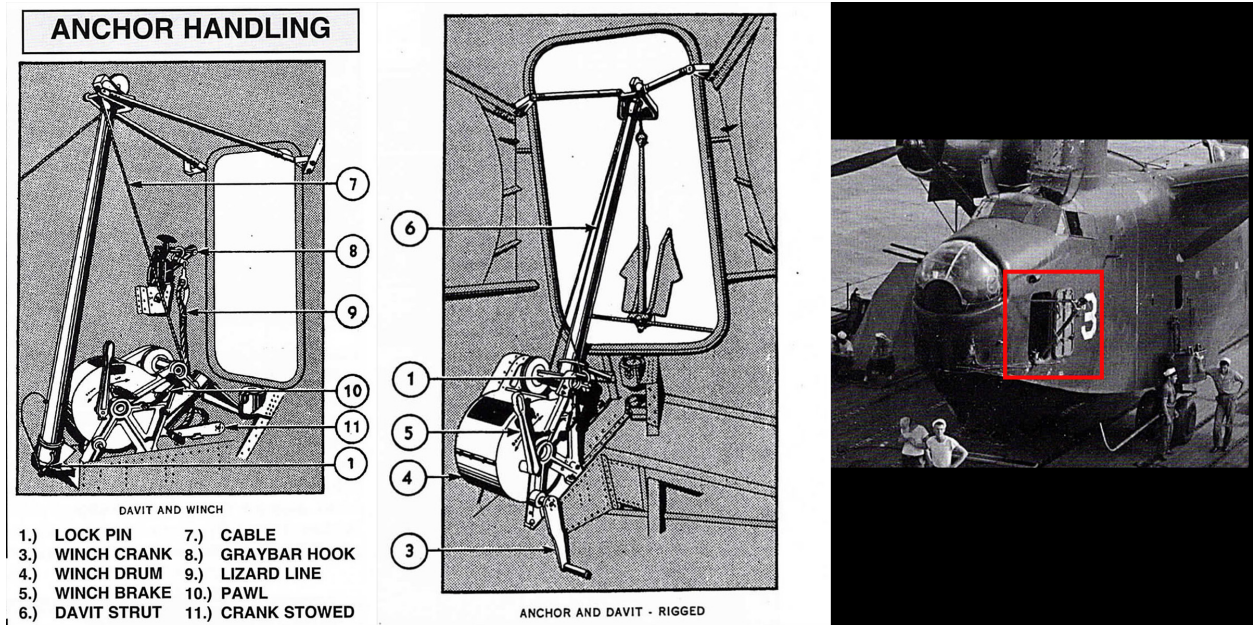
FIGURE 4.37. Illustrations of anchor davit and winch and photo of deployed anchor davit on PBM Mariner (emphasis added) (Images courtesy of Ginter, Steve. *Martin PBM Mariner* pages 83 and 177).

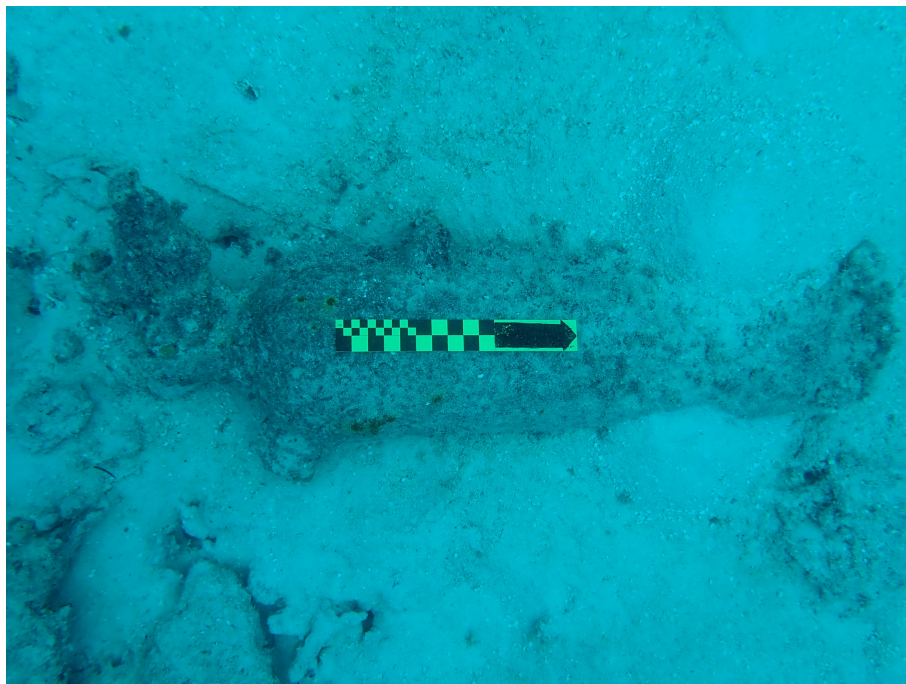
FIGURE 4.38. Mariner Site JATO tank (Photo taken by the author on 26 July 2019).

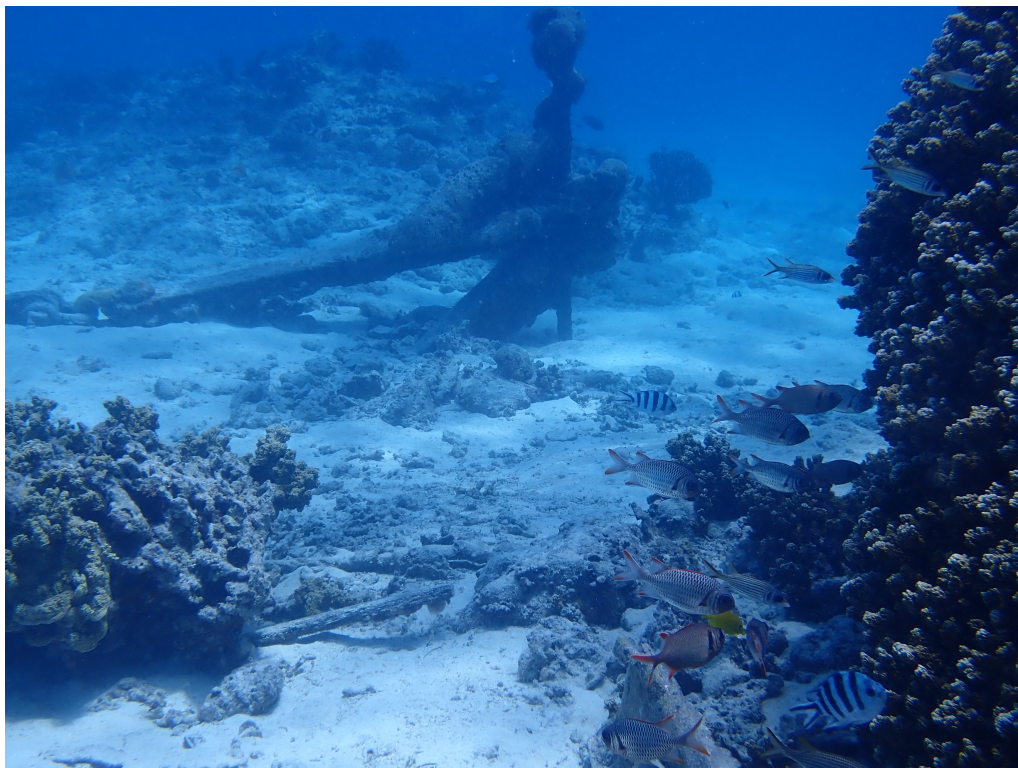
FIGURE 4.40. Large Danforth anchor located in the Mariner site (Photo taken looking approximately north by author 26 July 2019).

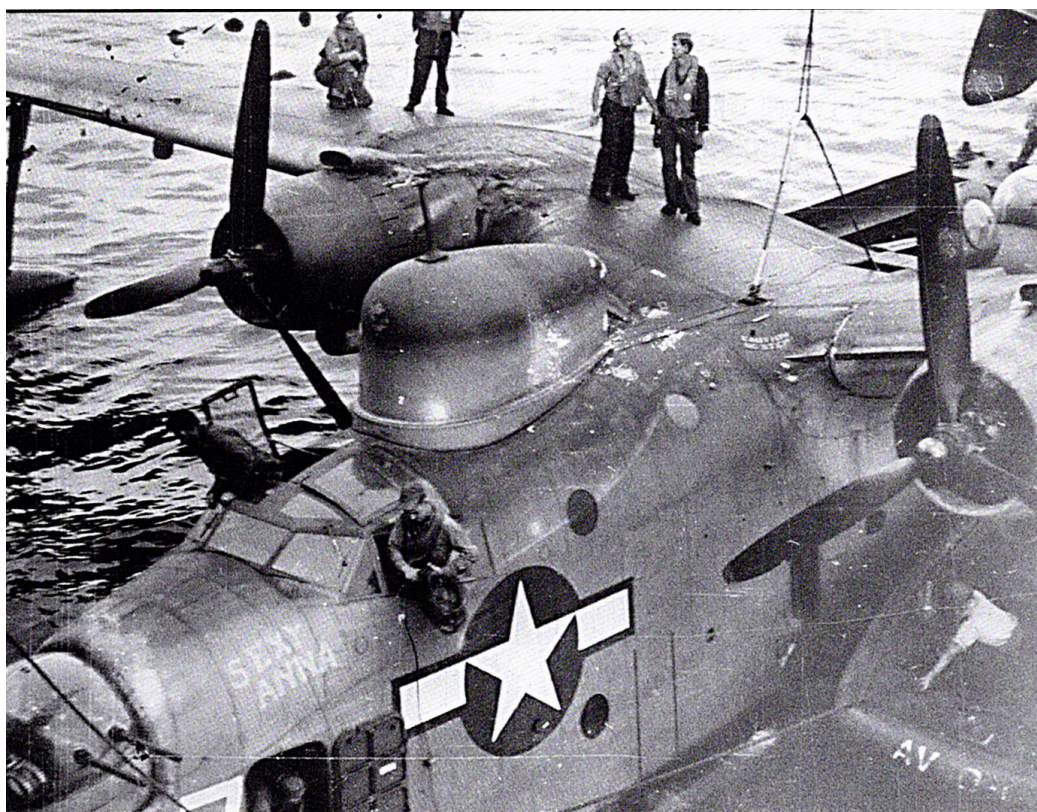
FIGURE 4.42. Photo of PBM Mariner being rigged from hoisting. Note the lifting eyes in the center of the gull wing structure (Image courtesy of Ginter, Steve. "Naval Fighters Number Ninety-Seven: Martin PBM Mariner." page 160).

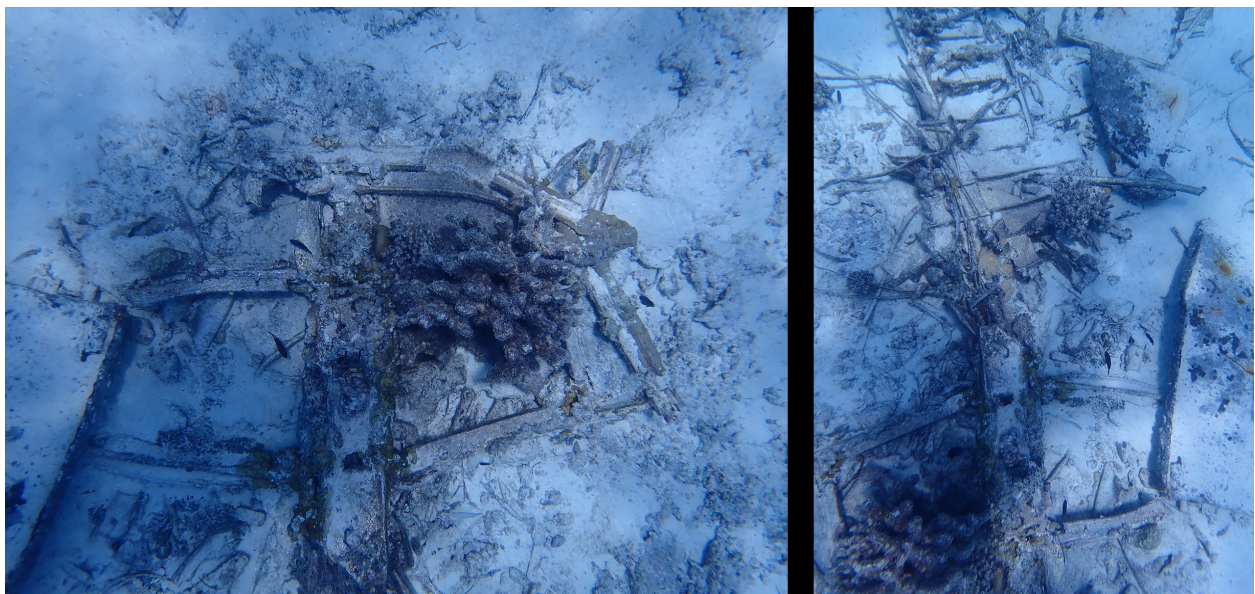
FIGURE 4.43. Overhead view of windows and roof of cockpit (left). Photograph on right is same looking aft (Photographs taken by author 26 July 2019).

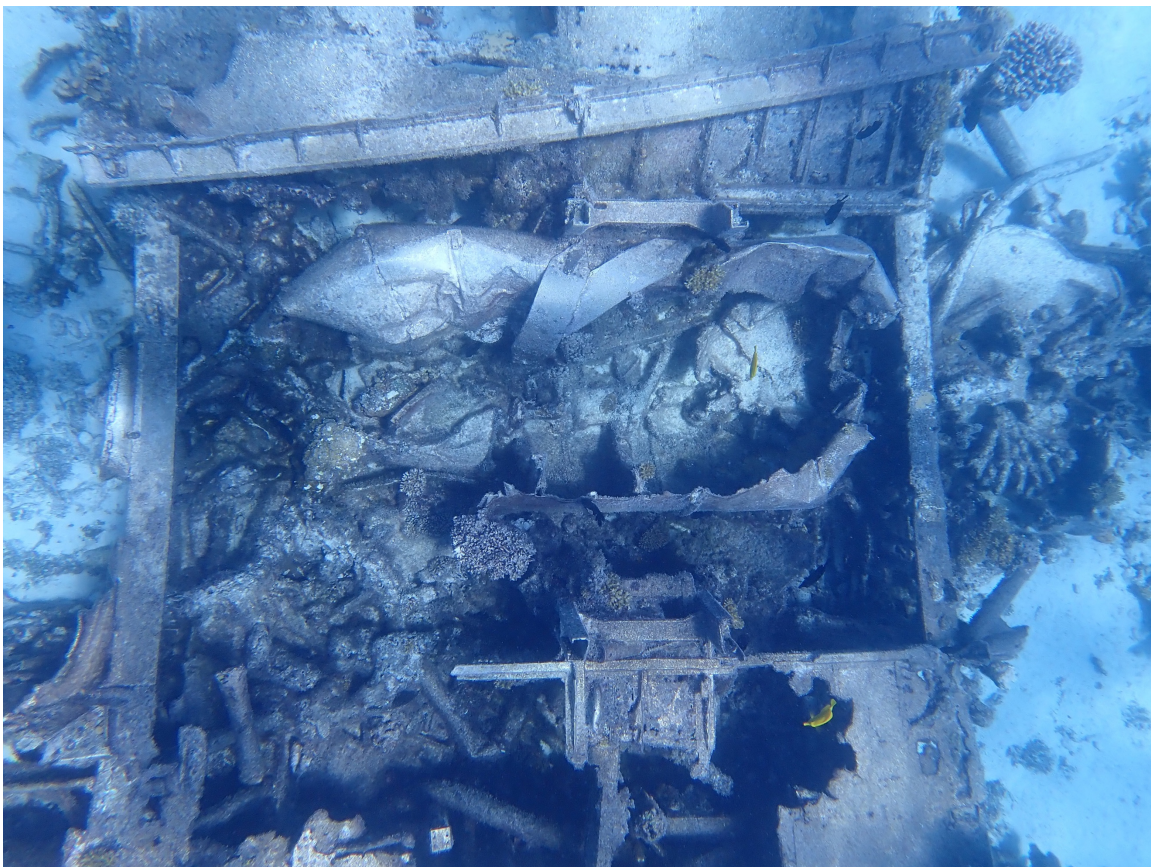
FIGURE 4.44. Image of fuel tank in the starboard nacelle which has possibly been ruptured due to an explosion (Photograph taken by author on 28 July 2019).

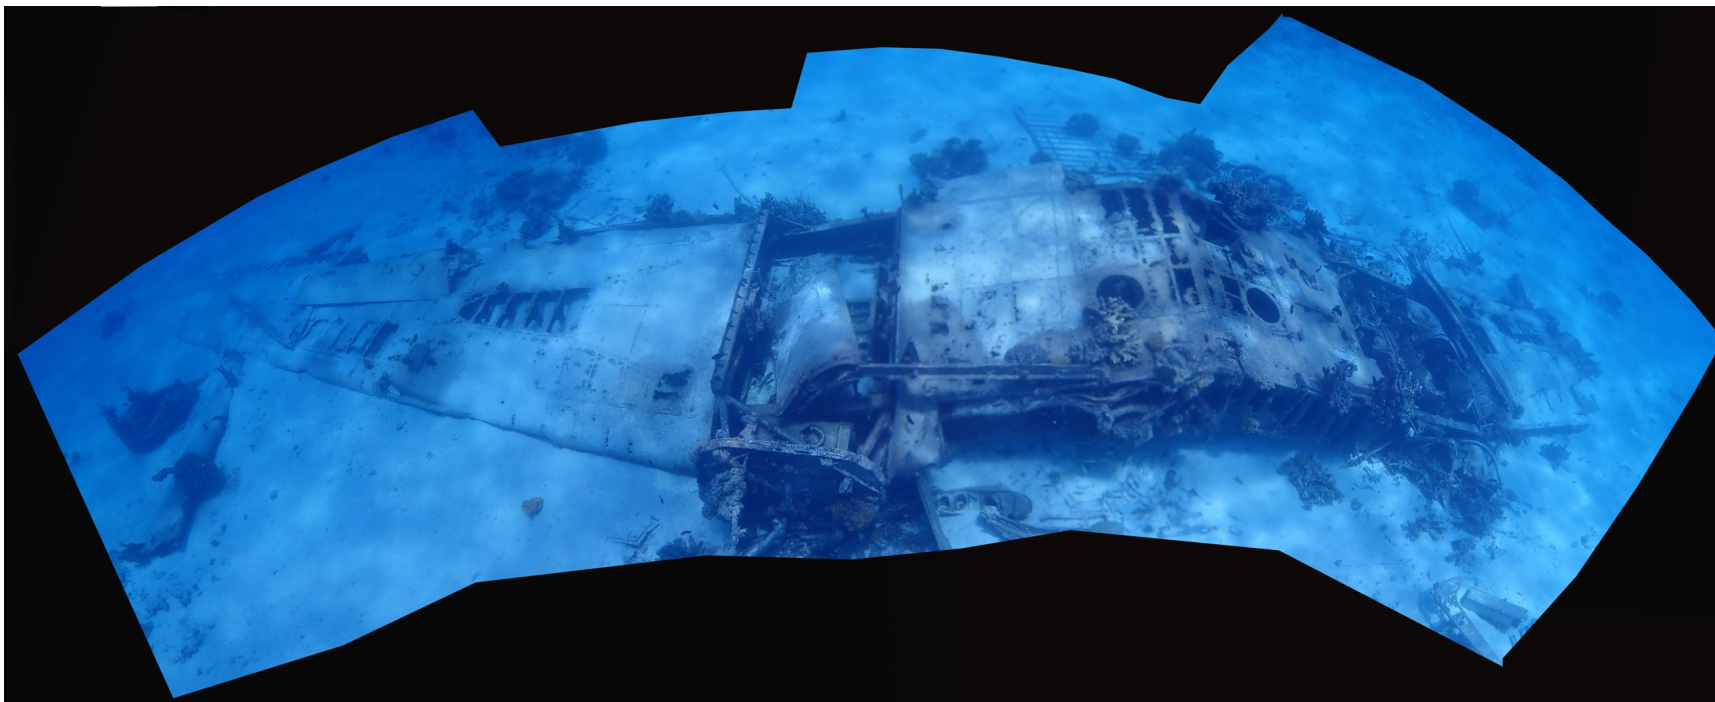
FIGURE 4.45. Panoramic view of the main gull wing section of the PBM Mariner. Image is off-center with the central control point being to the inside of the port nacelle. Note the nearly completely intact port wing and the large missing section of the starboard wing (Photographs taken by the author on 28 July 2019 and edited in Adobe Photoshop).
